USACERL Technical Report 98/34  
January 1998

# Seismic Mitigation for Equipment at Army Medical Centers

Methods Illustrated With Examples from Madigan Army Medical Center

by  
James Wilcoski

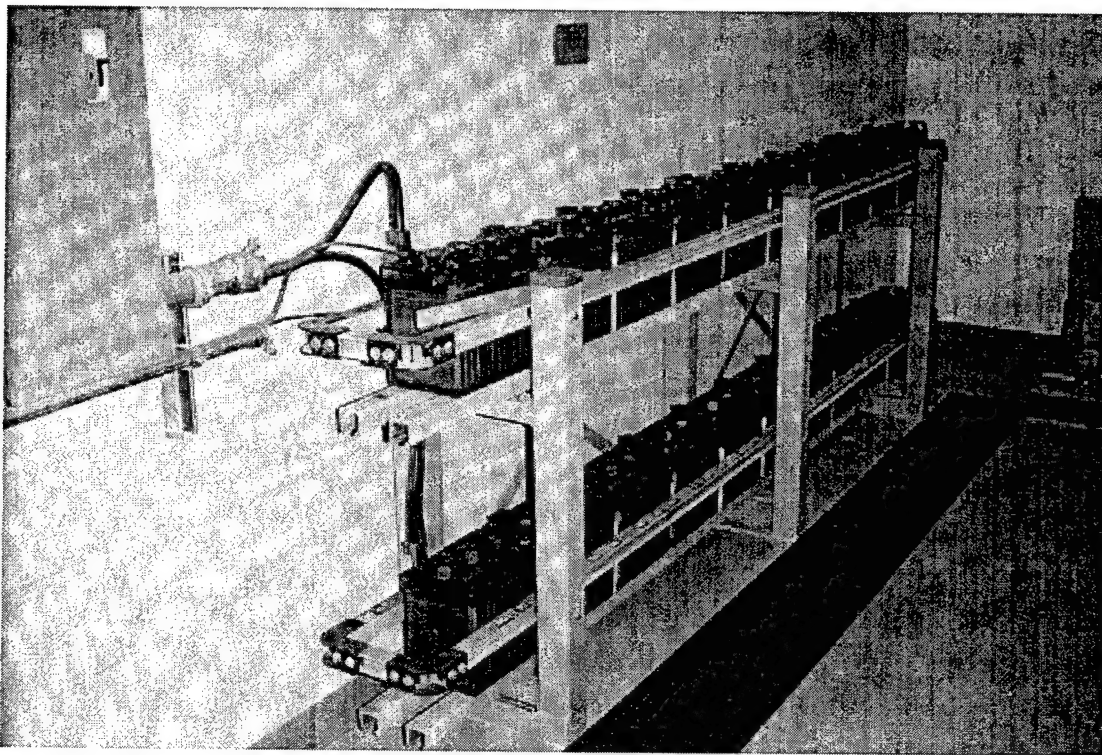
Figure 9. Station batteries that provide UPS for switch gear.

Figure 9 (see Chapter 2) showed the station batteries that comprise the UPS for the switch gear. The frames are well anchored, but Figure 50 shows that the batteries are not snugly supported in the frames. The same foam spacers used between the batteries are needed on the sides of the batteries and at the ends of the racks. The spacers must be sized to provide a snug fit.

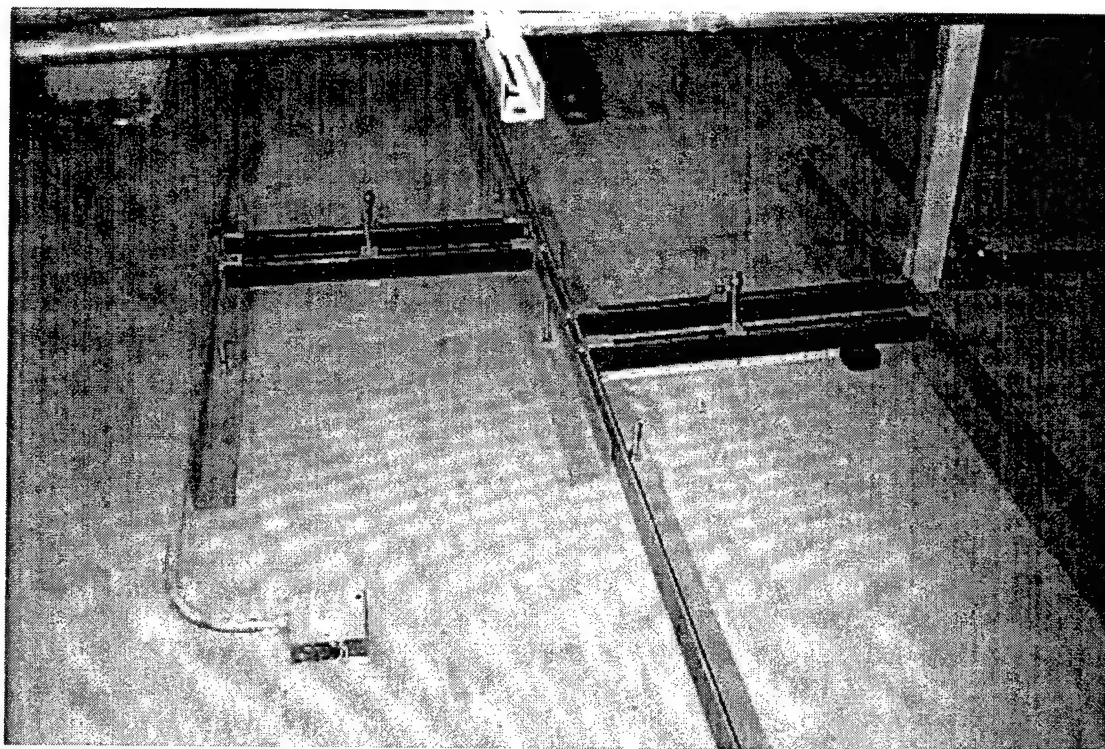
Figure 19 shows overhead suspended pipes in a mechanical room. These appear to be well suspended with tie rods and braced with cables. The cables carry tension only, so they must extend to the ceiling structure in all four directions (e.g., north, south, east, and west) in order to carry the seismically induced loads in both lateral directions. Overhead anchored equipment is supported through the ceiling by the interstitial floors. Figure 20 shows an overhead anchored telescopic arm supporting an x-ray head (collimator). The supporting rails appear to be well anchored to the overhead interstitial floor. Figure 21 is a view looking down at an interstitial floor showing a frame that distributes the load from overhead anchored equipment below to the interstitial floor. Based on the site visit it could not be determined what this frame is supporting, but it

appears well constructed to serve its purpose of preventing punching shear through the interstitial floor.

**Figure 21. Interstitial floor showing frame that distributes loads for overhead-anchored equipment.**

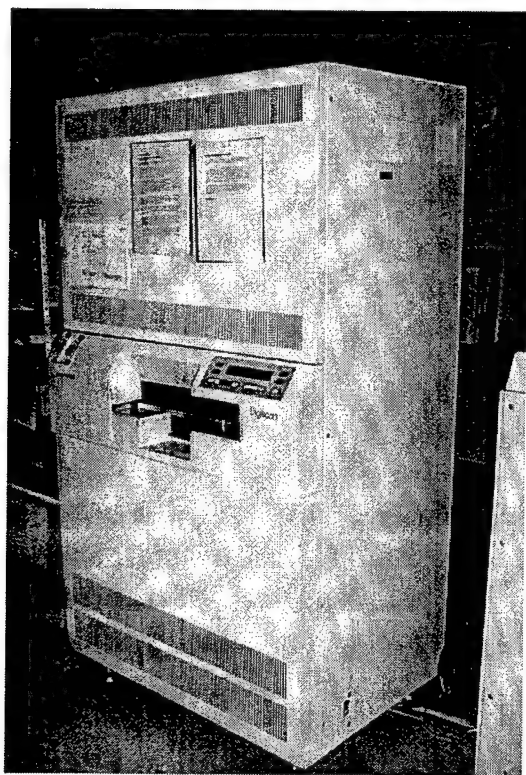
Figure 24. Digiscan (Fuji 7000) supporting the Medical Digital Imaging Control Center system.

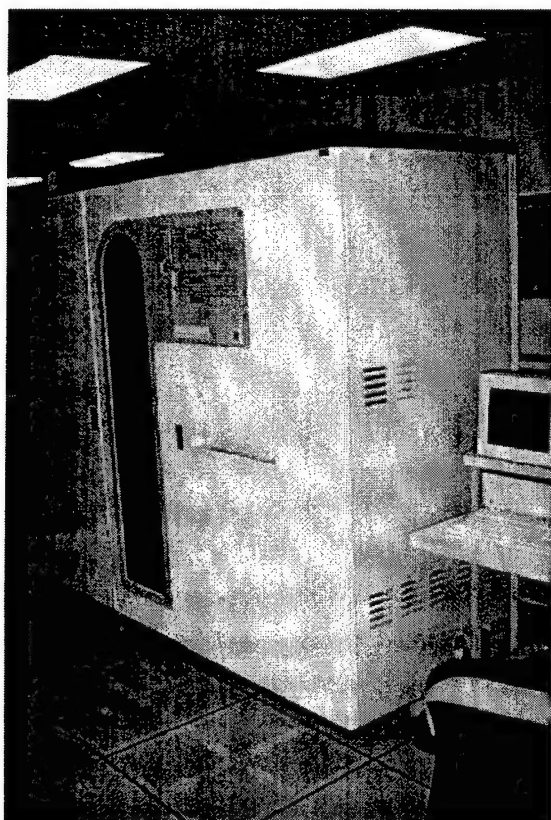
Figure 26. Kodak Optical Disk System (6800-ADL).

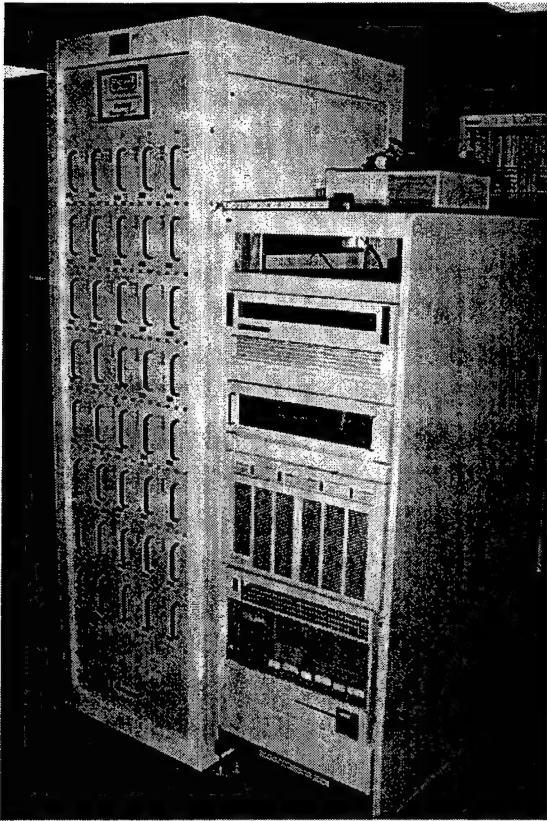
Figure 29. Digital-VAX mini-computer CPU supporting the MDICC.

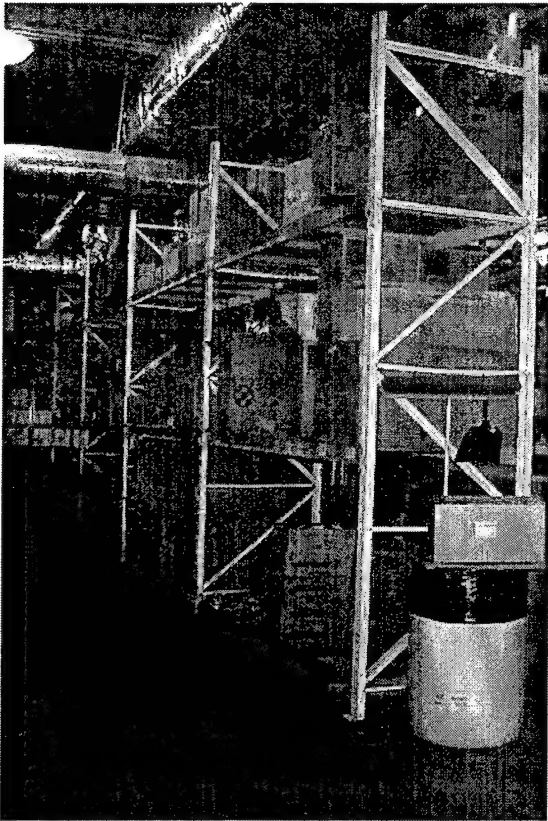
The logistics area provides shipping and receiving services plus some storage. Figure 37 shows tall narrow storage racks that are unanchored (Figure 38). The storage rack leg shown in Figure 38 has bolt holes for anchoring the unit to the floor. These should be fastened to the floor, or they may also be braced by bolting to each other, to a wall or to the ceiling structural system. If bolted to each other, they should be fastened near their tops and bottoms to form a T or L configuration, as described above for the pharmacy shelves. Shelf bracing must be designed so as to avoid long unsupported lengths of shelving. Figure 39 shows 55-gallon barrels stacked loosely. In an earthquake, these could easily topple and injure workers, damage property, or rupture. These barrels should remain stable if they are simply unstacked.

Figure 37. Tall, narrow storage racks in the logistics area.

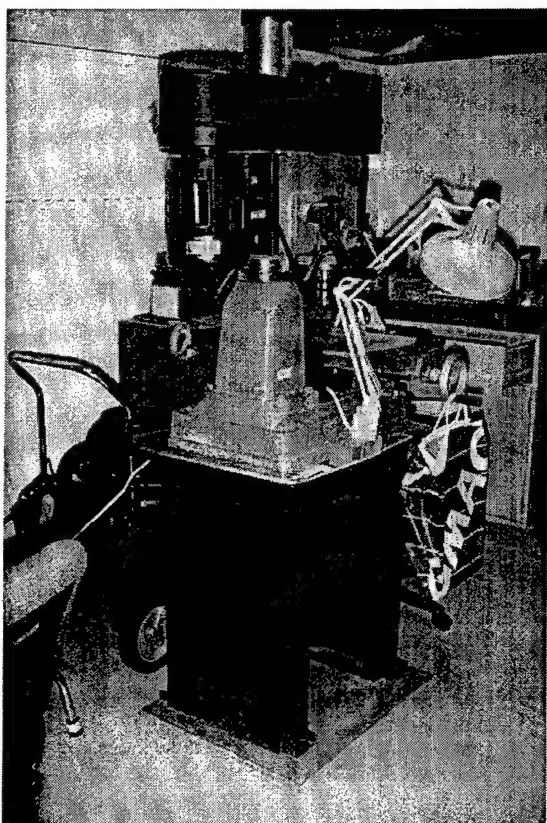
Figure 40 shows an unanchored milling machine that is fairly tall and has a narrow footprint. The bolt holes shown in Figure 41 demonstrate that this

Figure 40. Tall, narrow milling machine.

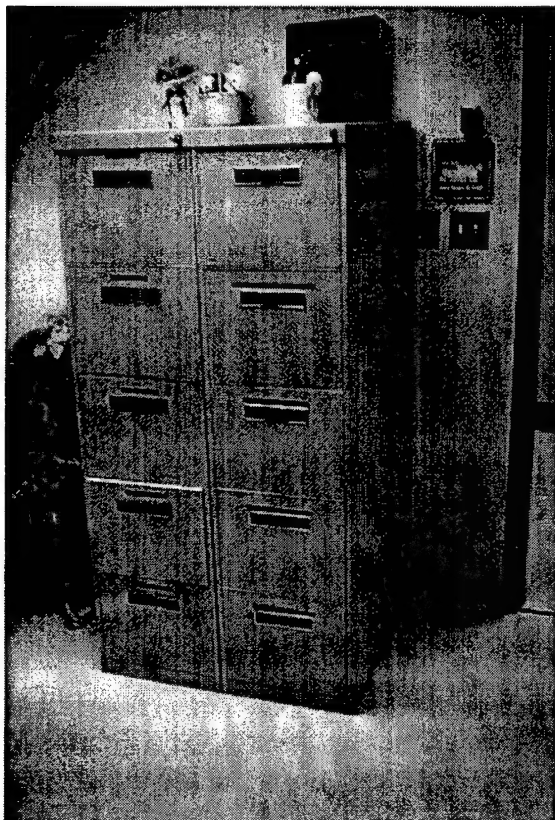
**Figure 45. Typical office file cabinet.**

Many offices throughout MAMC have unanchored personal computer CPUs and monitors, as shown in Figure 44. These can easily be anchored to their desks with Velcro strips or double-sided foam tape. The foam material assures that the tape will conform to slight irregularities in the surfaces. Double-coated acrylic foam tape Number 4950, manufactured by the 3M company, has a holding power of about 80 pounds per square inch (0.5 megapascals), so a small patch at each corner would provide an effective restraint. Figure 45 shows typical office file cabinets that are unanchored and may easily topple, blocking escape through the doorway. The drawers on these cabinets have no latches, so several drawers may roll open at the same time, making the cabinets even more susceptible to falling over. Standard file cabinets with latches should be used, and the cabinets should be anchored or braced to the wall or each other as described earlier for shelving units.

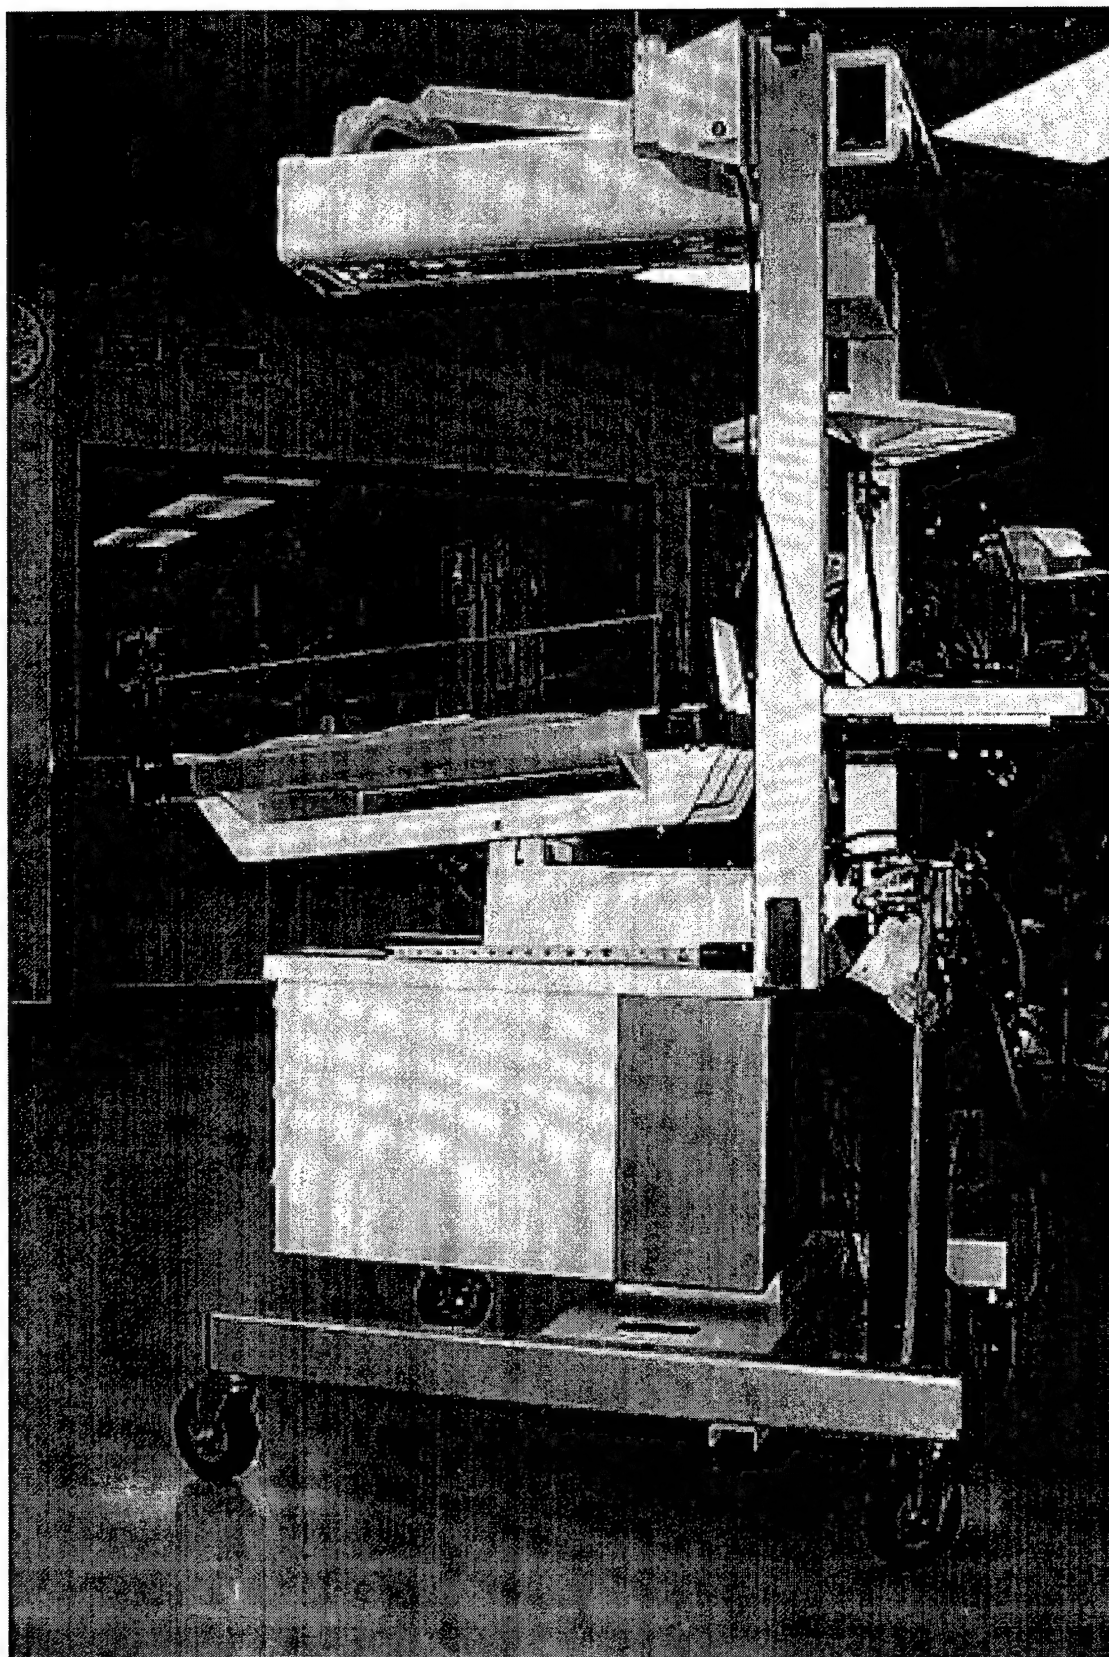
impact may damage either the equipment on wheels or whatever it hits, such as gas lines in intensive care units. It is recommended that the wheels on all such equipment be kept locked. Even with the wheels locked this equipment may fall over if the wheelbase is not wide enough relative to the height of the equipment center of gravity. If such equipment cannot be anchored, it can only be protected by increasing the wheelbase or lowering the center of gravity. Equipment on rollers was seen in the emergency room communications center, intensive care unit (ICU) rooms, ICU nursery, delivery rooms, operating rooms, and in the area near gamma ray cameras. Figure 47 shows a nursery bed on wheels in the ICU nursery. Figure 48 shows a monitor on wheels with a very narrow wheelbase. Figure 49 shows other equipment with a narrow wheelbase near the ICU nursery.

Figure 47. Nursery bed on wheels in the ICU nursery.

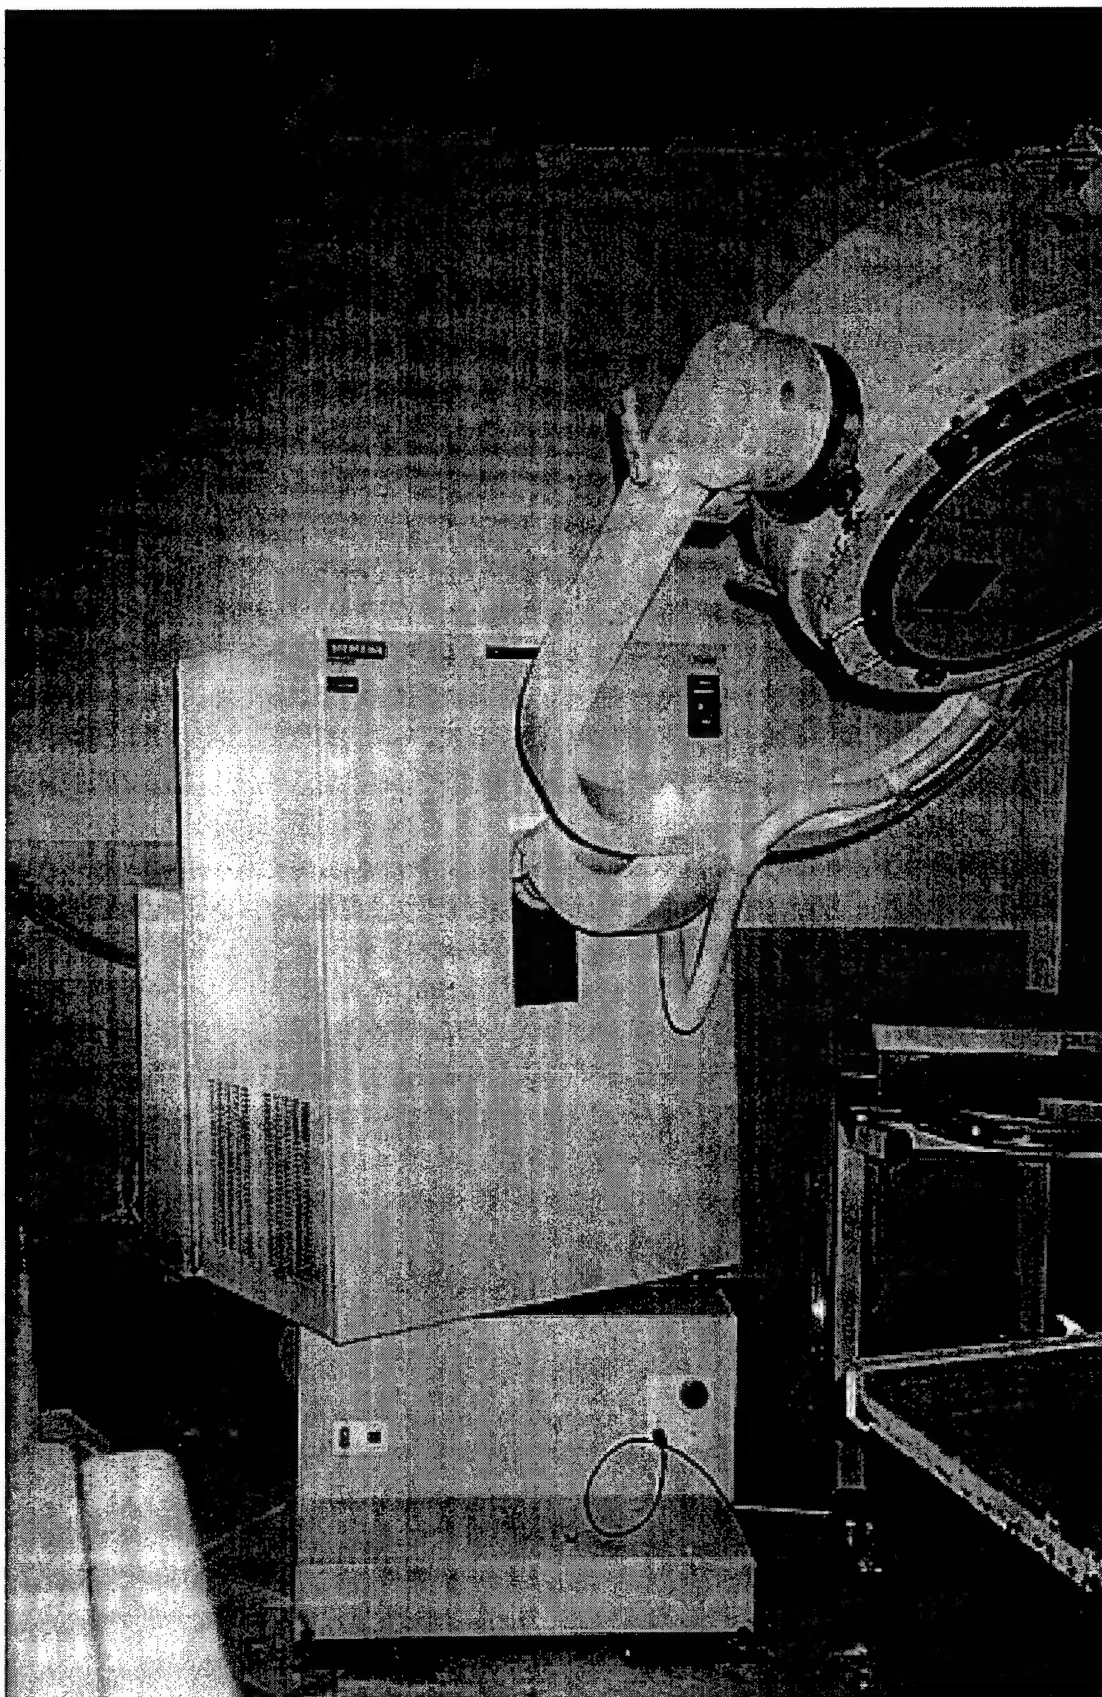
Figure 57. Single-head gamma camera damaged in the 1994 Northridge earthquake.
